ORNL/TM-2009/021

Effect of Intake Air Filter Condition on Vehicle Fuel Economy

February 2009

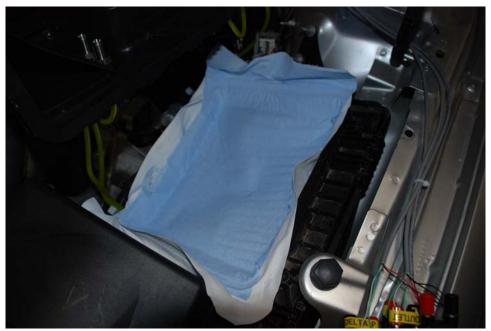
Fig. 2.3. 2007 Buick Lucerne filter restriction. Shop towels inserted into air box upstream of the air filter.

In all cases, the "new" air filter was a newly purchased aftermarket filter for that specific application. The simulated clogged air filter was another identical filter that was blocked off with a series of disposable shop towels to create the desired pressure drop. For the newer vehicles, the shop towels were placed in the air box on the upstream side of the air filter to increase the resistance of the air flowing through, as shown in Figs. 2.3 and 2.4. In the case of the 1972 Pontiac, the round filter was wrapped with shop towels to create the desired resistance, as shown in Fig. 2.5. Before the procedure for simulating a clogged filter was established, several filters were tested on the 2007 Buick. The OEM air filter was found to have a slightly higher pressure drop at WOT than several aftermarket air filters. The aftermarket filters were used for this testing to generate the largest difference between "clean" and "clogged" for these experiments.

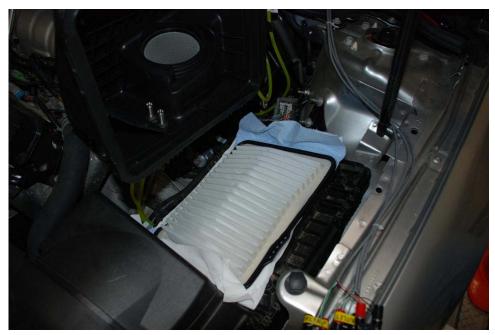
Fig. 2.4. 2007 Buick Lucerne filter restriction. Shop towels inserted into air box upstream of the air filter.

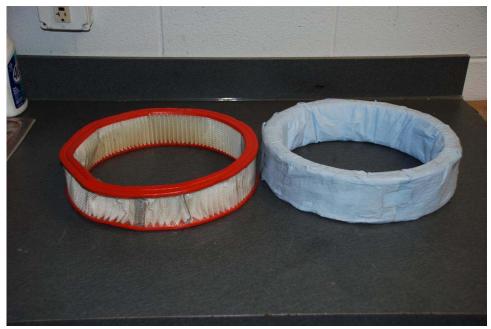
Fig. 2.5. 1972 Pontiac Grandville air filter. Filter on the left shows damage that occurred during "severely clogged" filter testing (see Sect. 3.3.1).

Wide-open throttle (WOT) tests were used to measure the changes in the filter pressure drop (Outlet DP). In a real-world application, the vacuum needed to set one of the air filter indicators would likely occur under heavy acceleration, such as merging onto an interstate, or climbing a steep grade. Therefore the level of restriction was set, using an artificial clogging technique described below, to achieve the desired Outlet DP during a WOT acceleration from idle to approximately 85 mph or a steady-speed (SS) WOT test in which the dynamometer was held at a fixed speed, 65 mph, and the throttle was held open for 10 seconds. Using these test procedures, the 2007 Buick Lucerne was configured to achieve an Outlet DP of approximately 7.0 kPa under the WOT acceleration and approximately 5.7 kPa under the SS WOT. Once the method for achieving this restriction was developed, it was used with each vehicle. Using this approach, the V8-equipped Dodge Charger showed a slightly higher Outlet DP than the V6 Lucerne, and the I4 Camry showed a slightly lower Outlet DP. The 1972 V8 Pontiac was restricted in a similar manner and level. It is important to note that all the modern vehicles used rectangular cartridge style air filters (Figs. 2.3 and 2.4), while the 1972 Pontiac used the cylindrical filter element common in that era (Fig. 2.5).

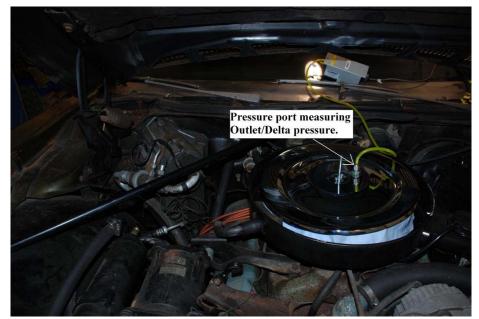
Fig. 3.12. Pressure port location for 1972 Pontiac Grandville.

To investigate the effect of a clogged air filter on a carbureted engine, a 1972 Pontiac Grandville with a 455ci V8 engine was also tested (Fig. 3.11). The Pontiac was only instrumented with the electronic delta P pressure transducer reading the Outlet DP during testing, configured so that it measured the pressure after the air filter and referenced that to the ambient air pressure. This setup is shown in Fig. 3.12.

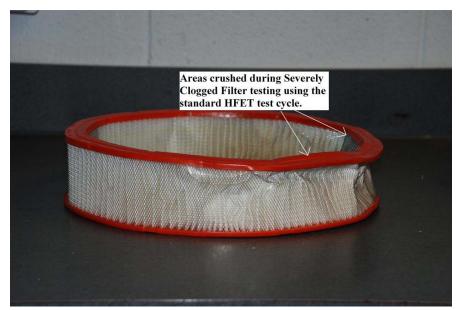
Fig. 3.18. Damaged air filter from severely clogged air filter testing, 1972 Pontiac Grandville.

The filter restriction in the Severely Clogged Air Filter Test 3 configuration (black column, Fig.3.17) was so severe that the driver had to consciously drive the vehicle in a manner that would not increase the throttle fast enough to cause a rich misfire condition during the HFET cycle. Once rich misfire was encountered, the vehicle was not able to maintain speed, and therefore, the test was invalid. The Filter Test 3 configuration also resulted in the air filter being crushed by the air filter cover. Figure 3.18 shows a picture of the air filter after removal of the shop towels.
